NUMBER 13: JULY 1957

The BBC Riverside Television Studios: The Architectural Aspects

by E. A. FOWLER, L.R.I.B.A.

Building Department, BBC Engineering Division

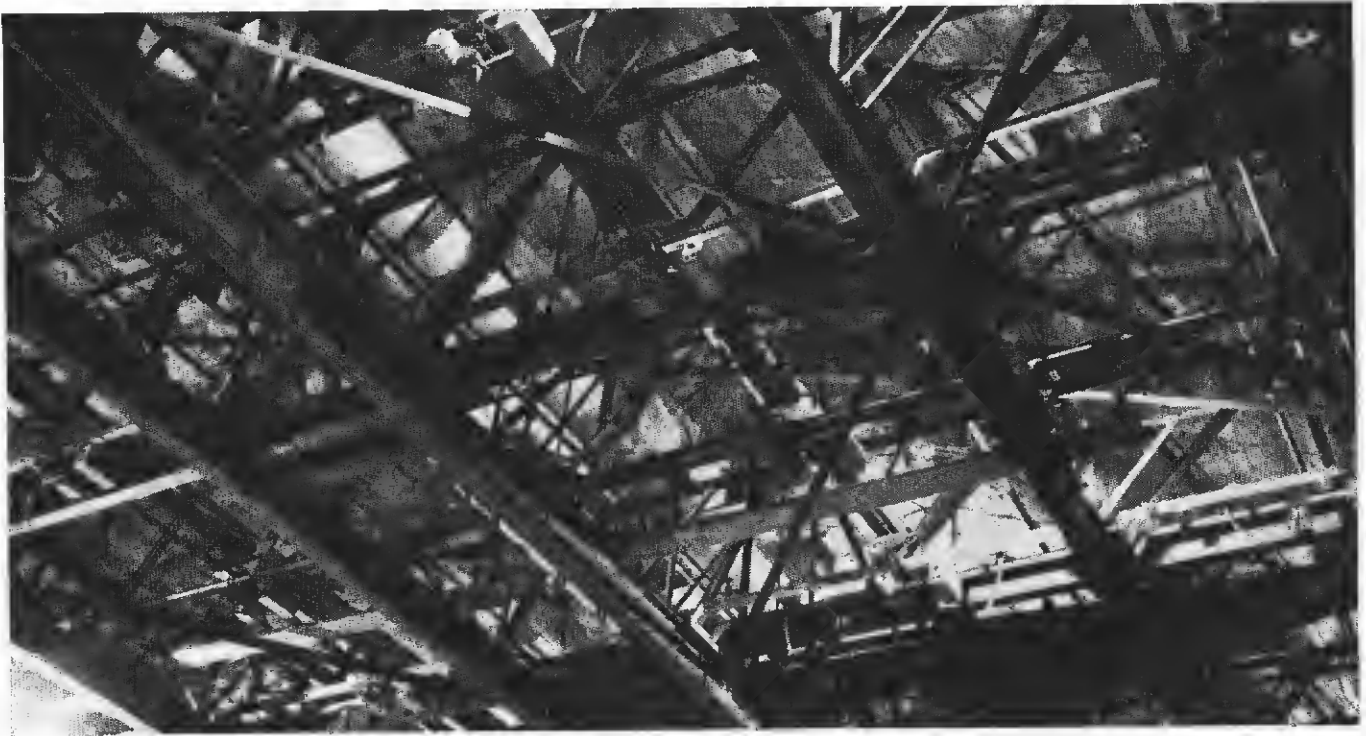
Plate B — Studio 1. Independently supported steelwork incorporating runway beams, motorized lighting batteries, and cable tray supports

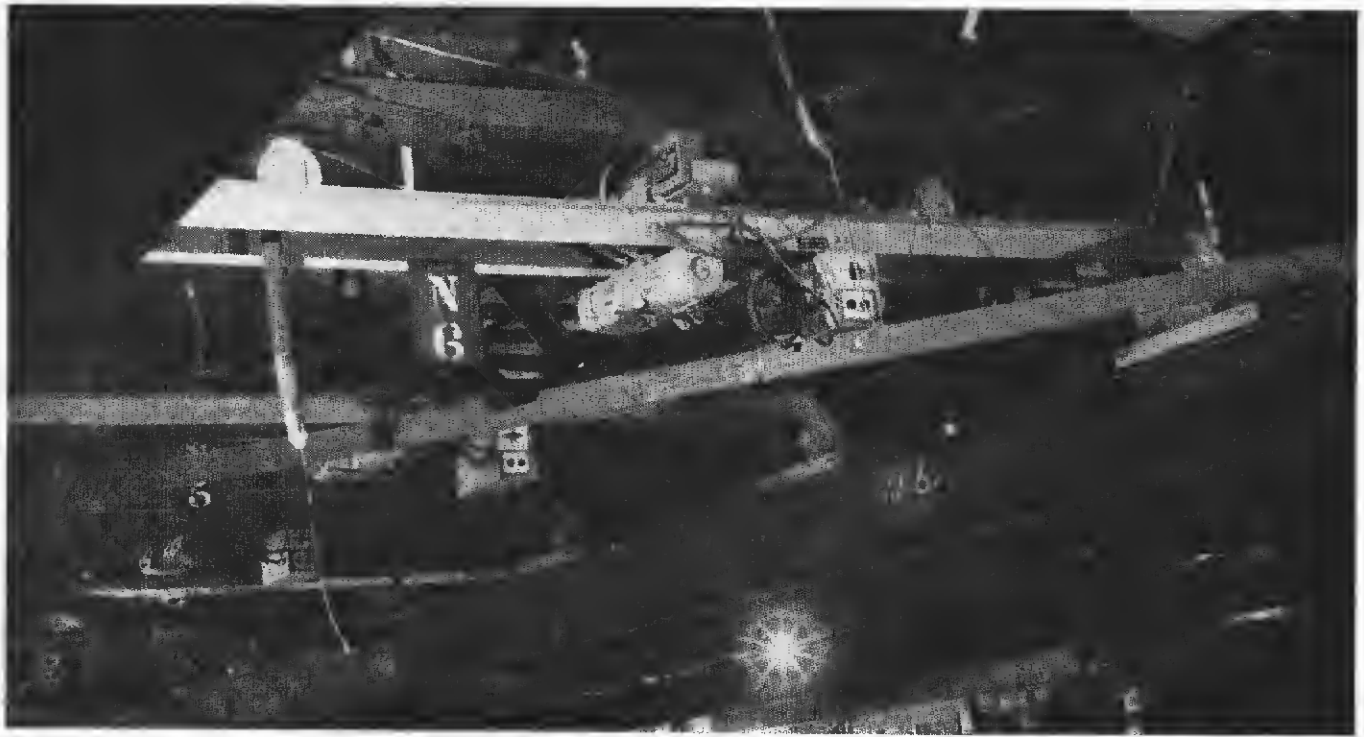
Plate C — Detail of typical motorized lighting batten

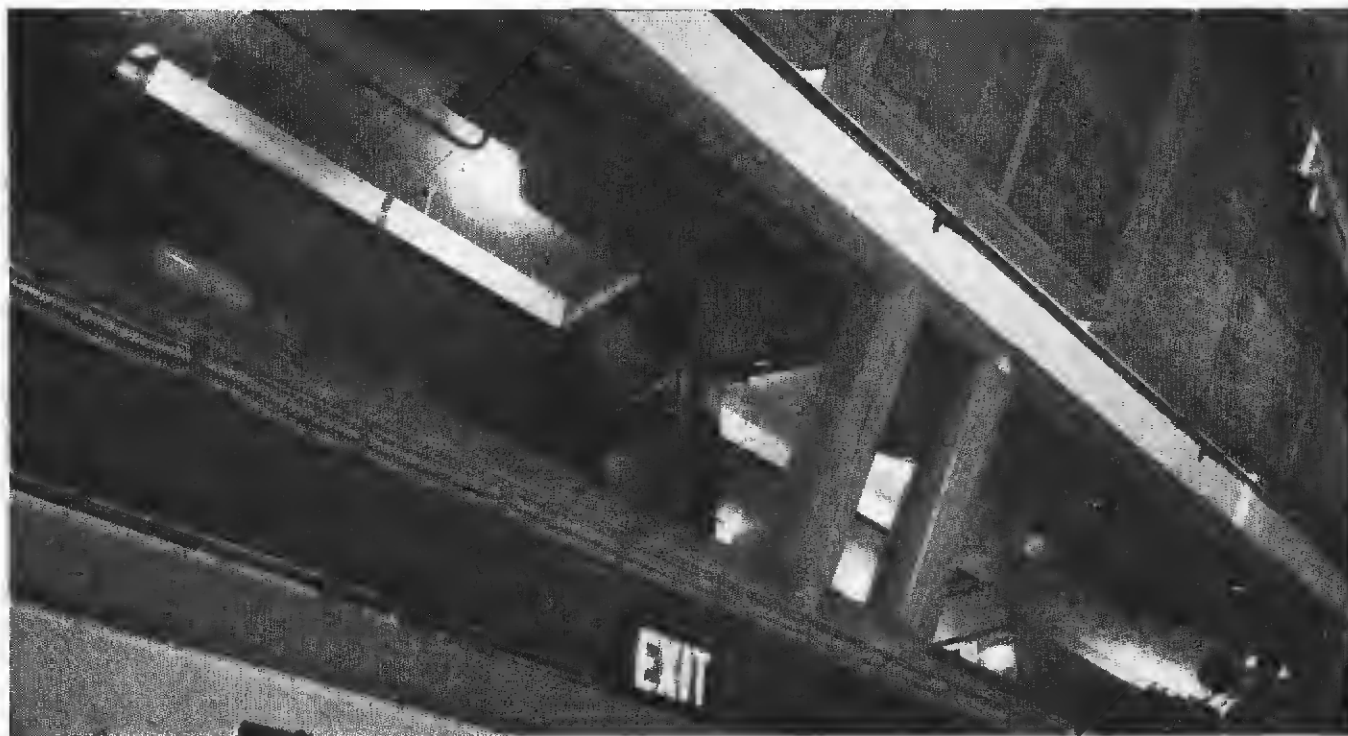
Plate E — View of Studio 1. Control suite windows from studio

the action on the studio floor and in the monitors simultaneously (see Plates E, F, and G). The equipment in these control areas was arranged to allow of 'front viewing' and power-operated windows were provided between the control rooms and apparatus room. The internal partition walling to the technical areas was formed with Camden partitioning. See Fig. 8 for detail.

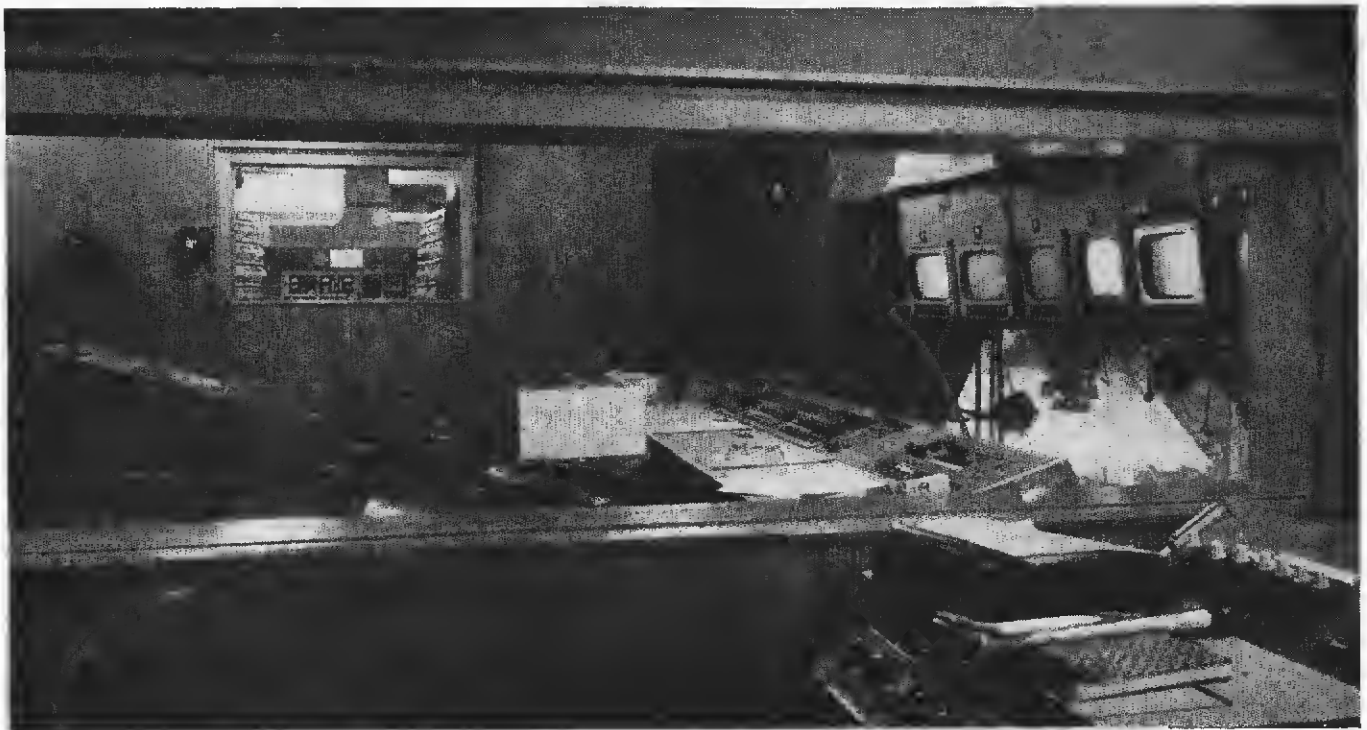
Plate G — View of Studio 1. Control suite power-operated window
